**ELLIS ISLAND
STATUE OF LIBERTY NATIONAL MONUMENT**

**HISTORIC STRUCTURES REPORT
UNITS 2, 3 AND 4**

**Volume 4
Part Two**

**Beyer Blinder Belle/
Anderson Notter Finegold**

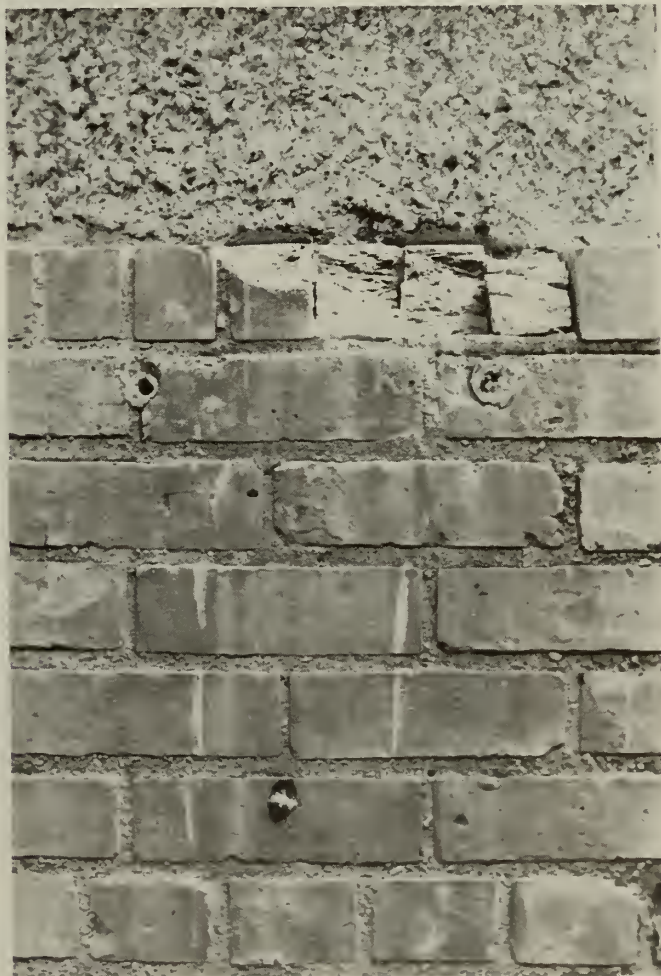
21. Damaged brick base, east end of south elevation, kitchen.

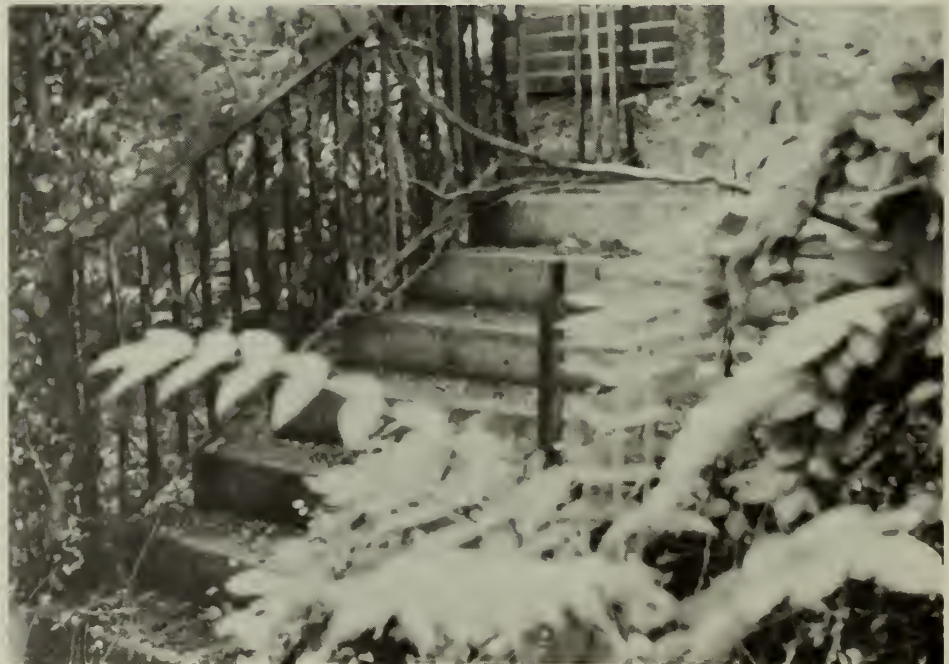
23. Deteriorated stair railing, kitchen, south elevation, view northwest.

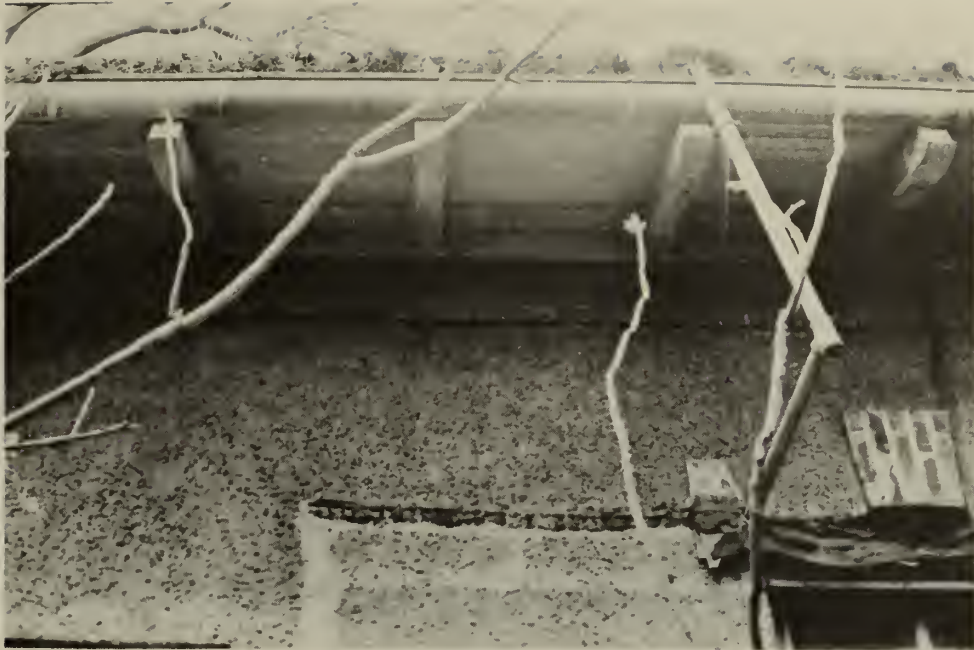
24. Kitchen gutter, south elevation, clogged by vegetative growth.

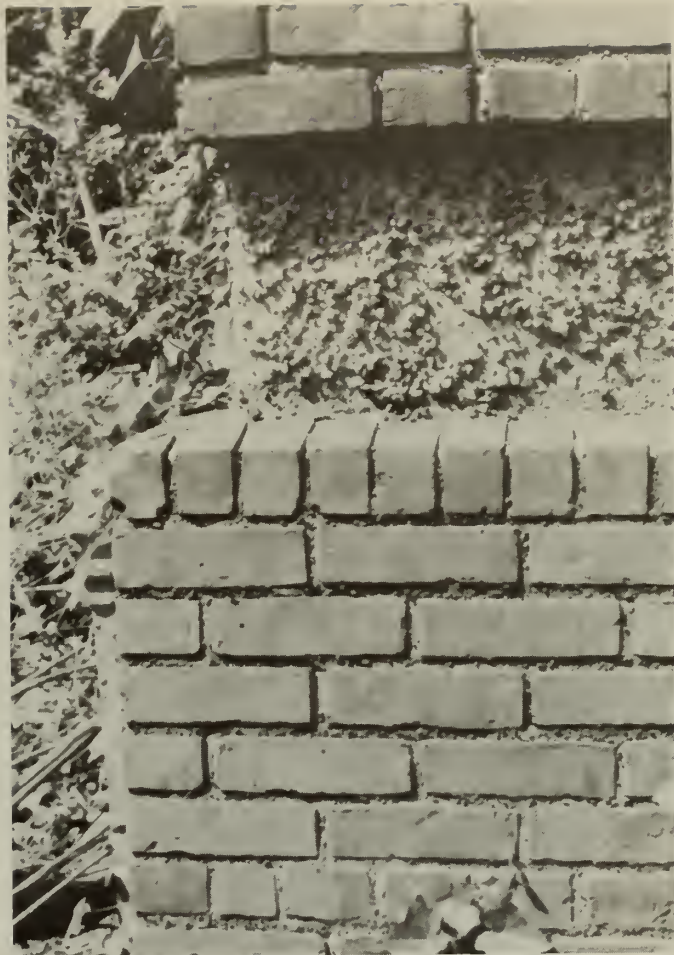
13. Mortar deterioration, base of south elevation of ward I.

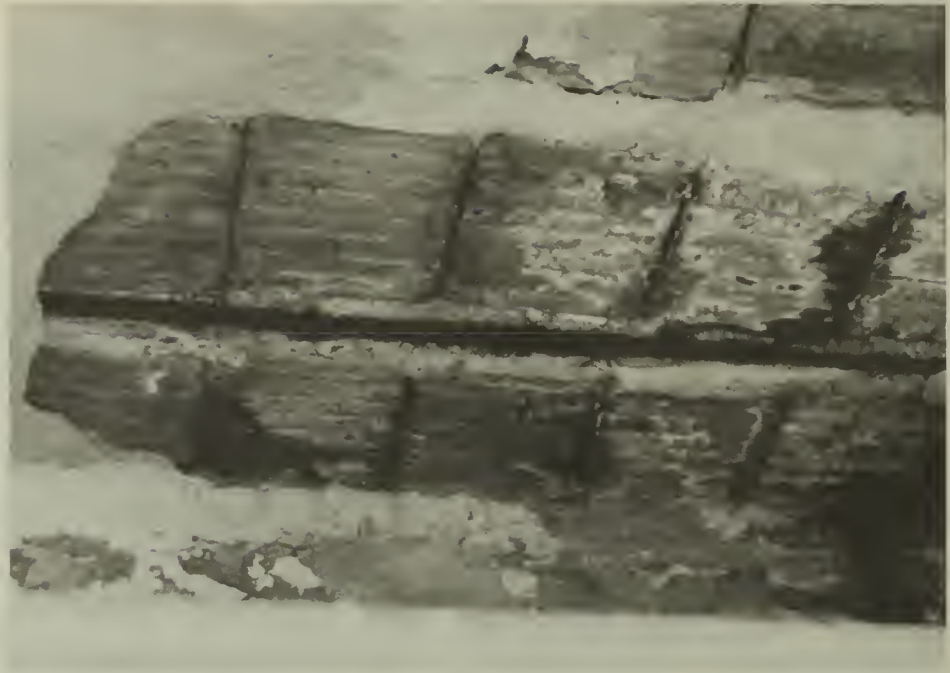
22. Ward K, room 109, ceiling; exposed and corroded reinforcing bar.

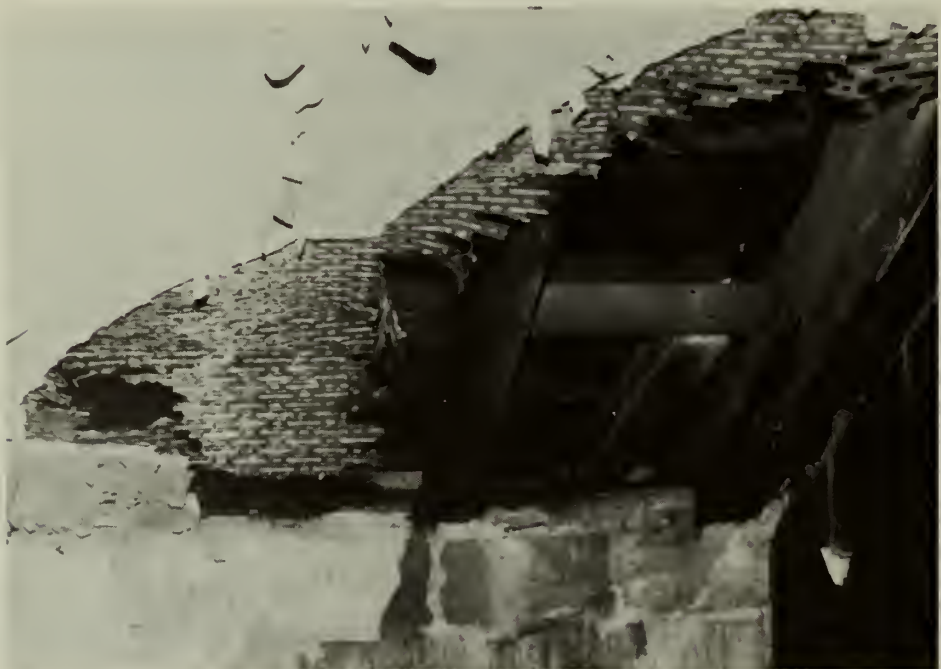
23. Ward K, room 203, water damage; exposed ceiling and roof members.

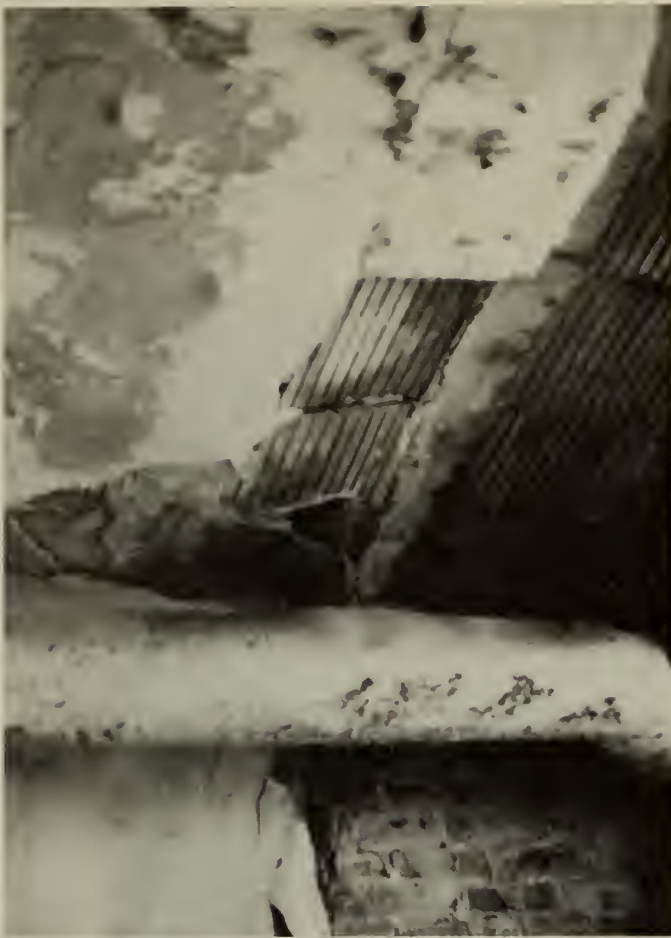
24. Ward L, water damaged ceiling; exposed clay tiles.

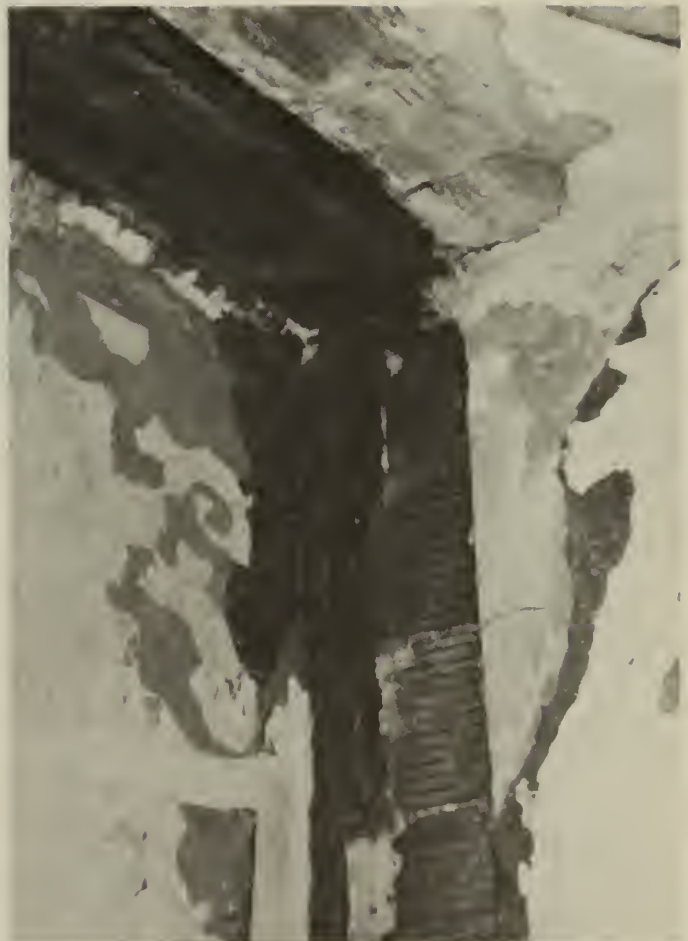
25. Ward L, first floor main corridor; exposed clay tiles.

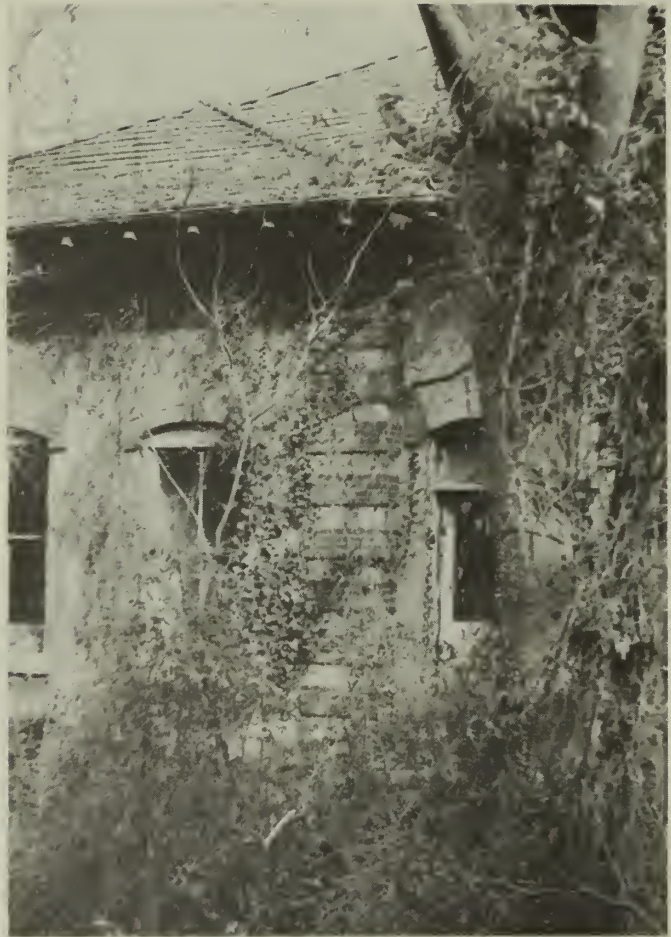
26. Ward L, south elevation;  
cracks.

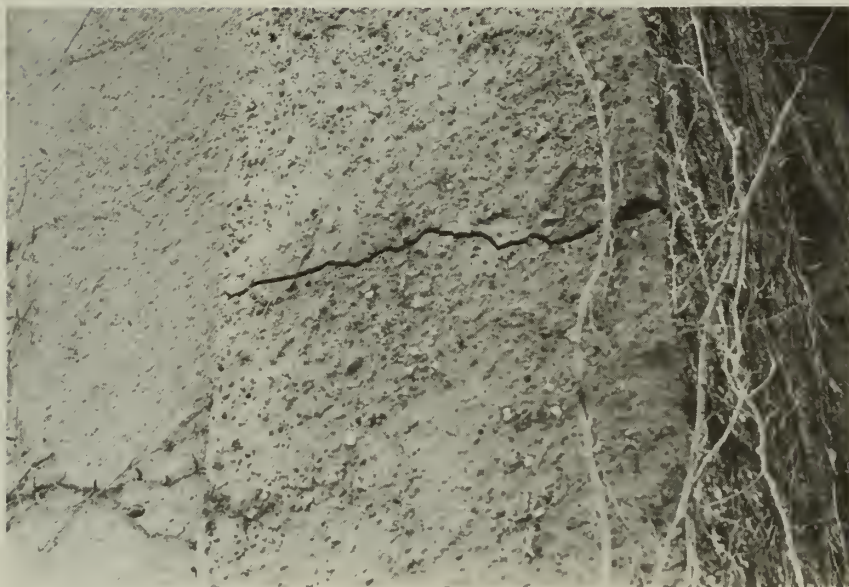
12. Cracking of stucco surface, porch.

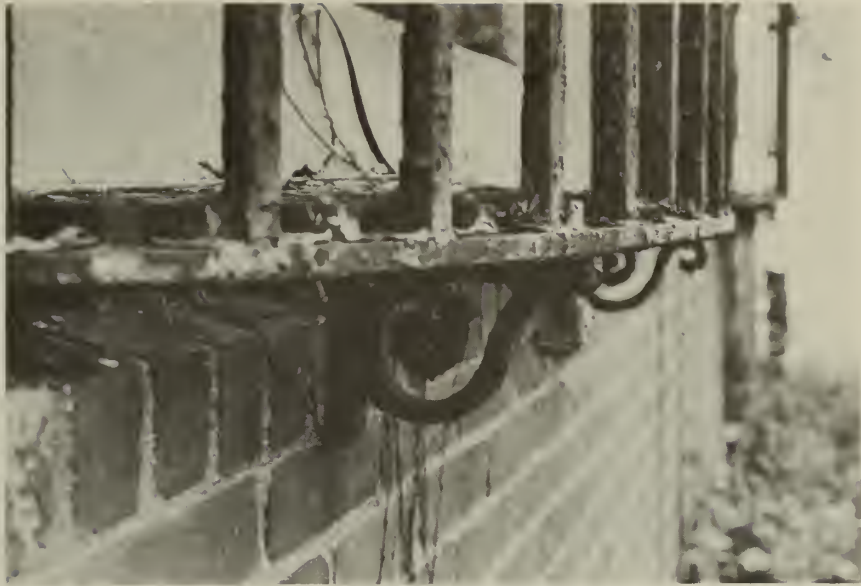
13. Rusted balcony, south elevation.

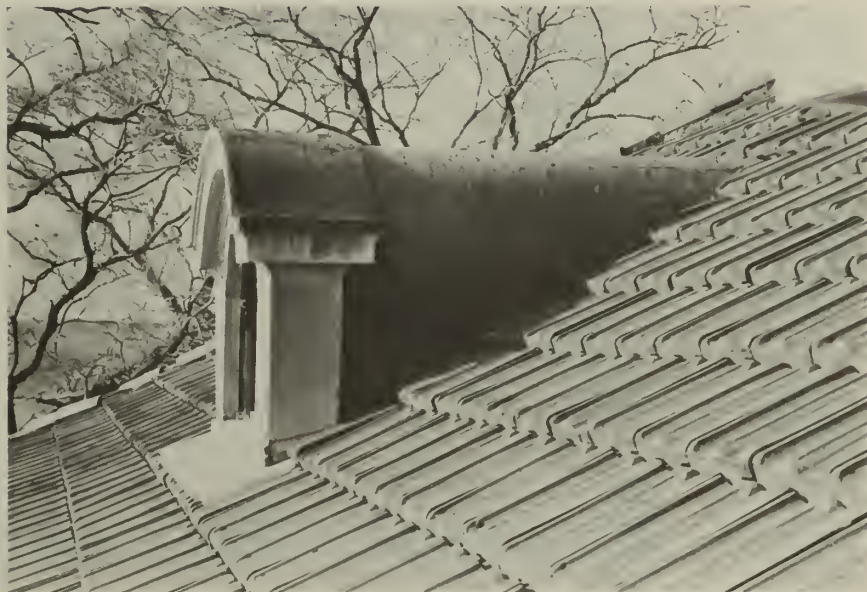
14. Tar-coated copper-roofed dormer.

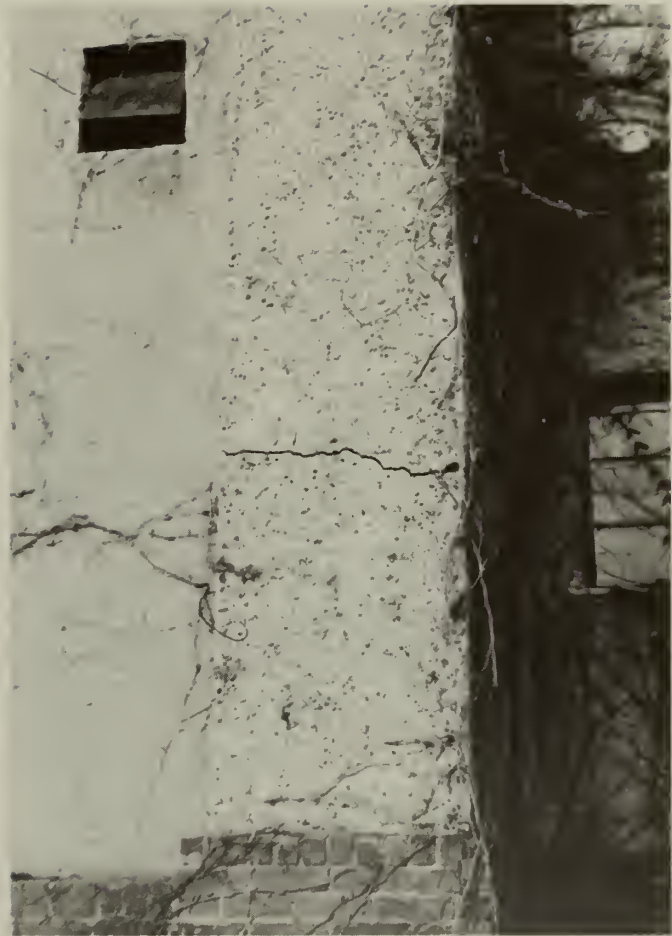
29. Crack in pier, east porch.
